Collapse of a Deep Excavated Foundation Pit in the Soft Soils by 3-D FEM

Abstract: In view of the collapse of a deep excavated foundation pit of the Xianghu subway underground station in Hangzhou of China, the main features of the accident are analyzed, and the induced factors of the accident are summarized. Then, a 3-D FEM analysis model is created to demonstrate the soil-support structures interaction system, and the effect of the main factors, such as the volume replacement ratio of the bottom soil reinforcing, the asymmetric ground overload, the embedded depth of the diaphragm wall, the shear strength of the bottom soils disturbed by the construction, and the excessive excavation of the bottom soil, are analyzed and compared. The results show that the ineffective original reinforcement plan for the bottom soft soil is the most prominent factor for the accident, and the disturbance effect of the deep excavation on the shear strength of the bottom soft soil is another significant factor for the accident. Meanwhile, if the reinforcement of the bottom soft soil is canceled, an appropriate extension of the diaphragm retaining walls to the under lying harder soil layer can also effe

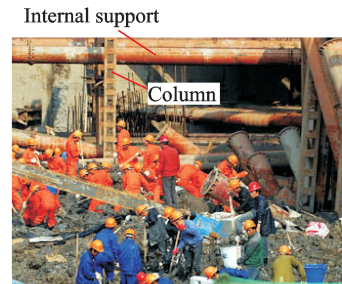
Fig.5 Cross-section of the foundation pit

enced area of the deep excavation, the dimension of the soil foundation cut from the half space is about $121\text{ m} \times 207\text{ m} \times 50.1\text{ m}$, as shown in Fig.4. The retaining structure of the foundation pit is an enclosed concrete diaphragm wall with thickness of 0.8 m. According to the original engineering design, its buried depth was about 33 m. The horizontal support system of the foundation pit is made by four-story steel pipes whose diameter is 609 mm and the wall thickness is 16 mm, which are installed by 3 m horizontal distance to each other and different distances in vertical direction, as shown in Fig.5. An

array of columns made by the steel-lattice rigid frame is installed to maintain the stability of the horizontal support system, as shown in Fig.5. The trans-section dimensions of the support structures are shown in Table 1.

By Fig.5 and Table 3, there are about 28 m

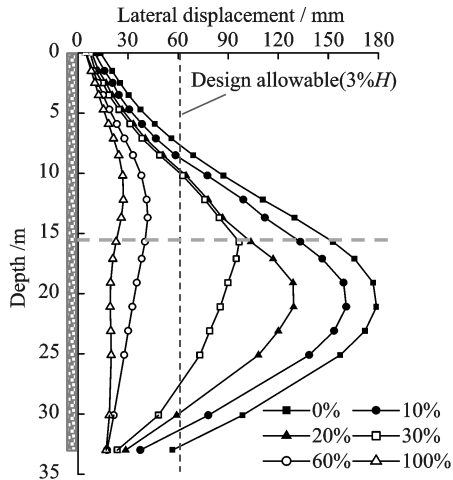
Fig. 10 Lateral displacements of the collapsed diaphragm wall

(a) Lateral displacement distribution of the collapsed diaphragm wall

(b) Relationship between m and the maximal lateral displacement

3 times of the design allowable. According to the Fig.10 (b), when m is larger than 50%, the maximal displacements of the diaphragm wall is less than the design allowable, and the influence of m weakens obviously. Generally, the influence of m on the maximal lateral displacements of the diaphragm wall in short edge of the foundation pit is not obvious. However, it should be noted that the large horizontal displacement at the end of diaphragm wall should induced by the soft soil layer which has not penetrated by the wall.

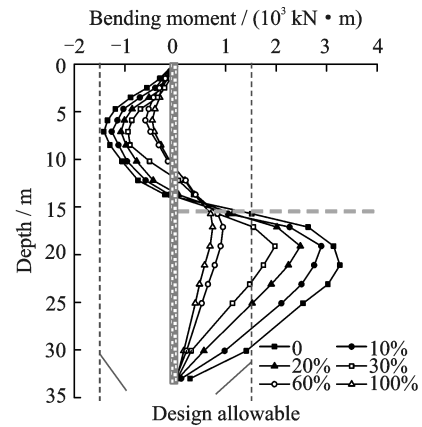
Fig.11 Internal force of the support structures under the different m

Fig.11 shows the bending moments of the diaphragm wall and the axial forces of the internal horizontal support under different m . By Fig.11 (a), when the bottom of the foundation pit is not reinforced, the maximal moment of the diaphragm wall is about 3 000 $\text{kN} \cdot \text{m}$, which is about 2.23 times of the design allowable. By the interpolation method, when m increases to 45%, the maximal moment of the diaphragm wall decreases to the design allowable. In general, m mainly influences the maximal

moment of the diaphragm wall in two places, which are at 7 m under the ground and 4—4.5 m under the bottom of the foundation pit, and are also very close to the broken points of the diaphragm wall in the accident. Meanwhile, the bending moment at 4—4.5 m under the bottom of the foundation pit is about 2 times that of at 7 m under the ground. By the above analysis, the diaphragm wall should be broken under the bottom of the foundation pit while it could not be broken at the place close to the ground. However, the diaphragm wall close to the ground has been broken in the accident, which should be damaged by the increasing bending moment after the break of the under diaphragm wall.

According to Fig.11 (b), m mainly influences the axial forces of the lowest two layer internal supports, especially the last layer supports. When the bottom of the foundation pit is not reinforced, the axial force of the lowest horizontal support is about 1.42 times of its limiting value. However, the axial force of another three layer supports are all smaller than the limiting value. In general, with m increas-

ing, the axial forces of the horizontal supports become smaller, especially the lowest layer supports. According to the accident, the horizontal supports have no obvious damages on the steel tubes, and the connection between the horizontal support and the diaphragm wall is damaged severely.

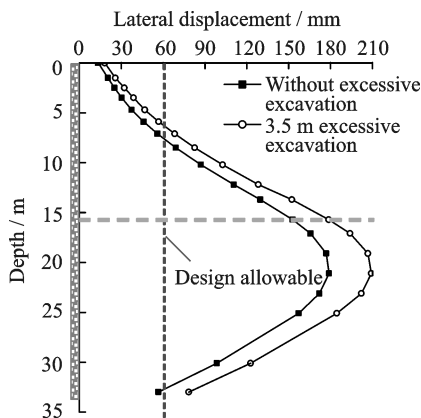
Fig. 12 Horizontal displacement curves of the wall at the collapse side of the foundation pit

Fig. 12 shows the lateral displacements of the wall on the cross-section where the last soil layer is excessively excavated. In general, the lateral deformations of the wall with excessive excavation are larger than those without excessive excavation. Fig.13 shows the internal forces of the support structures compared. As a result, the excessive excavation has little influence on the bending moment of the wall. However, it has great effect on the axial force of the nearest third layer horizontal supports, making it slightly larger than the limiting value. According to the above analysis, the excessive excavation should not be the main reason for the accident.

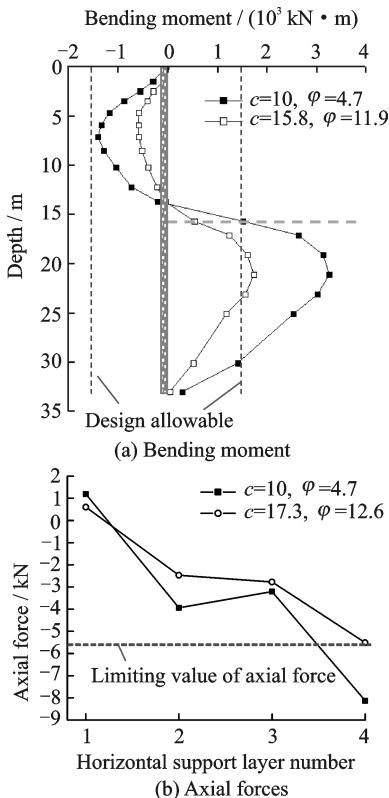
Fig. 15 Internal forces of the support structures under different shear strengths of the soft soils

Fig. 15 shows the internal forces of the support structures compared, and also shows that the disturbed soils have great effect on the bending moment of the diaphragm wall and the axial forces of

the lowest layer horizontal support. According to the above analysis, if the original shear strength parameters are used, the inner forces and the deformations of the support structures are all smaller than the limiting value, which proves that the support system of the foundation pit should be safe even if the soft soil at the bottom of the foundation pit wasn't reinforced. This may be the reason why the construction organization cancelled the original reinforcement design according to the original shear strength of the soft soils under the bottom of the foundation pit.

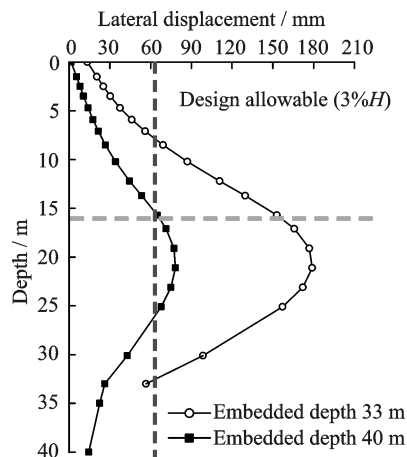
Fig. 16 Lateral displacements of the diaphragm wall under its different embedded depths

Fig. 16 shows the lateral displacements of the diaphragm wall compared. As a result, with the vertical length of the wall extending from 33 m to 40 m, its maximal lateral displacement decreases about 50% and is very close to the design allowable. Fig. 17 also

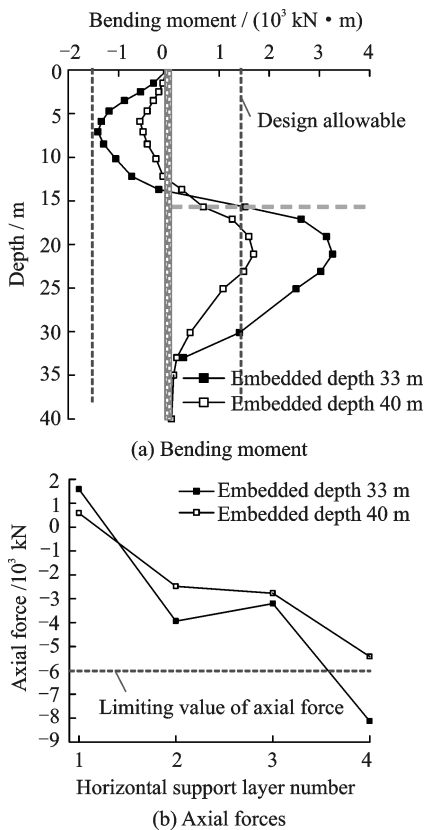
Fig. 17 Internal forces of the support structures under the different embedded depths

shows the internal forces of the support structures compared. In general, the embedded depth of the diaphragm wall has great influence on its bending moment and the axial forces of the lowest horizontal supports. When the embedded depth of the wall extends to the under harder silt clay layer, the support system may be safe even if the soft soils under the bottom of the foundation pit have not been effectively reinforced.

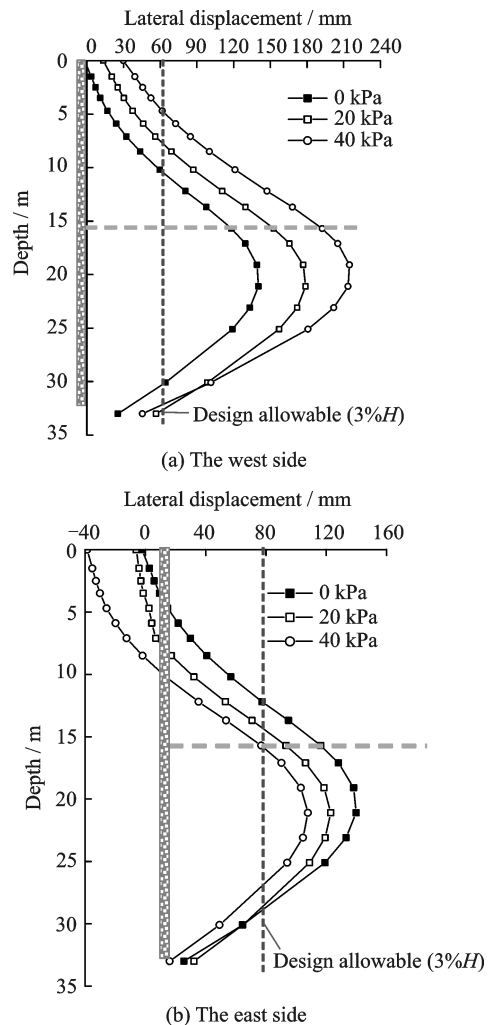
Fig. 18 Lateral displacements of the diaphragm wall under the different ground overloads

Fig. 18 shows the lateral displacements of the diaphragm wall compared. With the ground overload on the west side increasing, the lateral displacements of the west side diaphragm wall increases obviously, but it induces the lateral displacements of the opposite side diaphragm wall decreasing at the same time. Fig. 19 shows the bending moment of the diaphragm wall compared. Consequently, with the ground overload on the west side increasing, the bending moments of the west side diaphragm wall also increases obviously, which also induces the bending moments of the opposite side diaphragm wall decreasing at the same time. However, by Fig. 20, the asymmetric ground overload has little

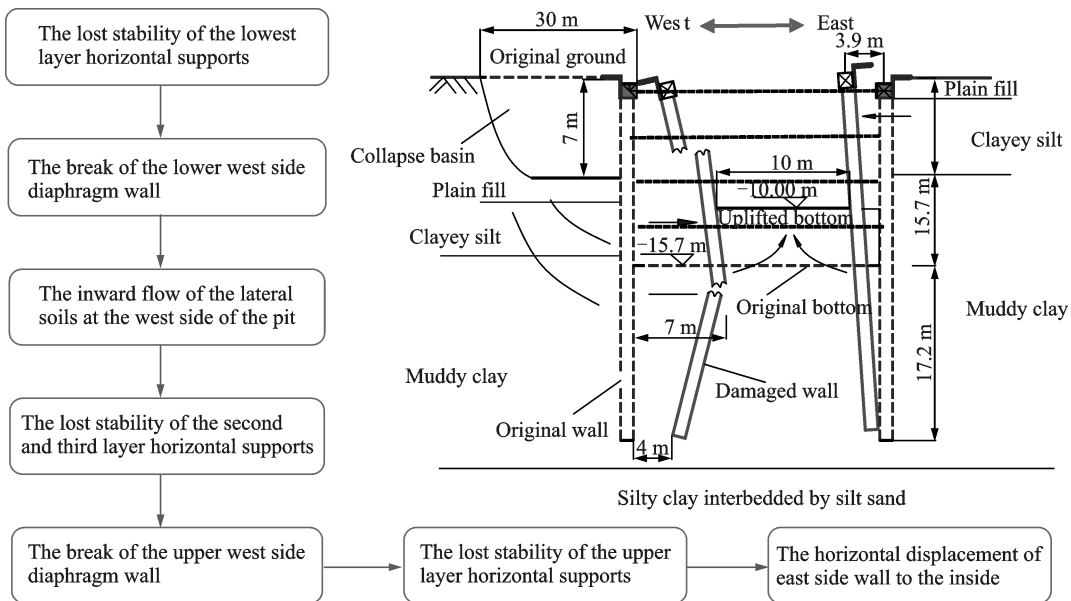
Fig.21 Development process of the accident by the numerical modeling and the investigation

According to the numerical modeling and the investigation on the accident, the development process of the accident can be deduced firstly, shown as Fig.21. The direct factor inducing the collapse of the excavation pit should cancel the foundation treatment on the soft soils under the excavation pit, which induced the axial forces of the lowest horizontal inner supports and the moment of the diaphragm wall are all exceed its limiting values. As a result, the lowest horizontal inner supports lost its balance and then the diaphragm wall under the bottom of the

pit is broken quickly. Then the supports on the second and third layers lost its balance instantaneously, which induced the upper diaphragm wall is also broken quickly, and then the soils behind the diaphragm wall flow into the pit quickly, and the bottom of the pit is lifted about six meters.

However, why the east-side diaphragm wall has not been broken in the accident? The main reason should be the overloading vehicles running on the west side of the foundation pit, which induced the west-side wall broken firstly, and then the uplifted bottom of the foundation pit should protect the east-side diaphragm wall from being broken.
