# Study on Ultrahigh Cycle Fatigue Performance of GH4169 Nickel-Based Alloy at 650 °C

**Abstract:** The fatigue test between  $10^5$ — $10^9$  cycles of GH4169 nickel-based superalloy commonly used in aircraft engines is carried out by ultrasonic fatigue machine at 650 °C. The S-N curve is obtained and the fatigue fracture morphology is observed. The fatigue S-N curve presents a “step-like” shape, with the first inflection point near  $1 \times 10^7$  cycles and the second inflection point near  $1 \times 10^8$  cycles. There is no engineering fatigue limit, and it still shows a downward trend after  $10^7$  or even  $10^9$  cycles. The crack initiation location is related to its life. Cracks are generated on the surface below  $10^7$  cycles, while it is inside above  $10^7$  cycles. The crack initiation source in the ultra-high cycle fatigue at 650 °C is mainly the local intergranular fracture and casting defect of the matrix. In the phase of crack propagation, the mixed propagation of intergranular and cleavage is the main form.

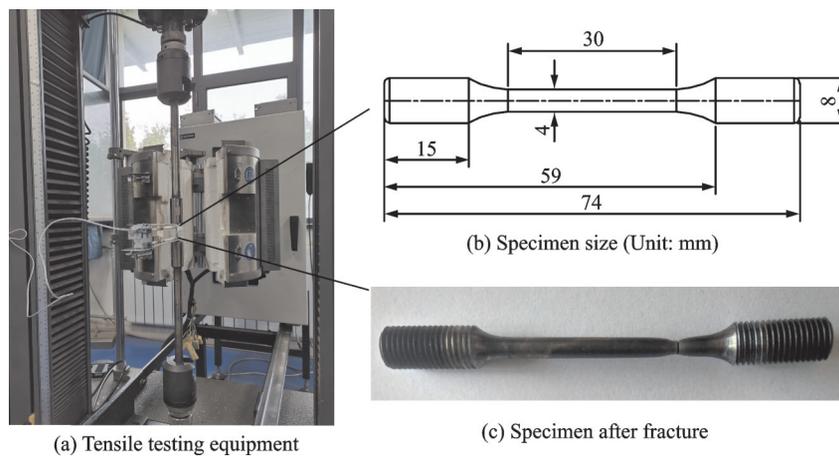
Fig.1 Tensile testing equipment and specimens at high temperature

Tensile tests were conducted on Instron 5982 electronic universal material testing machine according to GB/T4338—2006 and the test temperature was 650 °C. Strain control was used to control the loading speed of the test, which was 0.002/min before yield and 0.02/min after yield. After reaching 650 °C, heat preservation for 10 min before stretching. The three specimens were tested and the average value was finally taken. Fig.1 shows the size of the specimen of the high temperature tensile equipment and the specimen after fracture, and it can be seen that there are obvious traces of oxidation on the surface of the specimen.

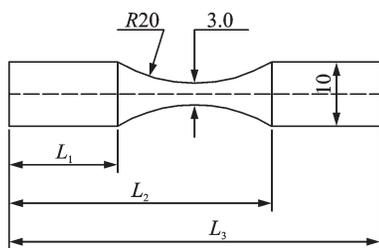
Fig.3 Dimensions of ultrasonic fatigue specimen at high temperature ( $L_1=15$  mm,  $L_2=39$  mm,  $L_3=54$  mm)

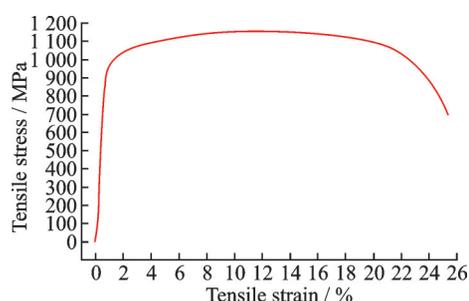
Fig.4 Stress-strain tensile curve of 1# specimen at 650 °C

The tensile properties of the three GH4169 alloy specimens at 650 °C are shown in Table 1. Fig.4 shows the stress-strain curve of 1# specimen and Young's modulus is obtained by fitting the elastic state. As can be seen from Table 1, GH4169 alloy has excellent high temperature tensile properties of yield strength of 937 MPa, ultimate tensile strength of 1 166 MPa, elongation of 22.75%, and elastic modulus of 167 GPa, which are far beyond the requirements of high temperature mechanical properties stipulated in the aviation materials manual<sup>[1]</sup>.

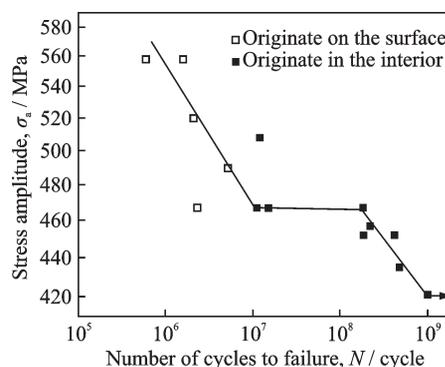
Fig.5 Fatigue S-N curve of GH4169 alloy at 650 °C

The S-N curve of GH4169 alloy is shown in Fig.5. The arrow in the figure indicates that the test was stopped without failure after reaching  $1 \times 10^9$  cycles. It can be seen from the figure that the S-N curve presents a “step-like” shape, appearing at the first inflection point near  $1 \times 10^7$  cycles and the second inflection point near  $1 \times 10^8$  cycles. The S-N curve of ultra-high cycle fatigue of alloy materials usually has a “stepped” or “double linear” shape with two inflection points<sup>[19]</sup>, which is a typical feature different from low cycle fatigue and high cycle fatigue.

Through the curve, it can also be found that the crack initiation location is related to the cycle. Before the first inflection point, that is, the specimen in the high cycle fatigue interval between  $10^5$  and  $10^7$ , the crack initiation occurs on the surface. Cracks were generated inside the specimens with ultra-high cycle fatigue life interval after the first inflection point. The research shows that the mechanism of fatigue crack source transfer is related to the competition between surface damage and internal damage of specimens, but there are different views on the explanation of this phenomenon. Shanyavskiy. et al.<sup>[20]</sup> believed that the internal stress was released due to stress concentration under high stress, and the surface crack played a major role at this time. The stress concentration in the material under low stress is the main factor of initiation. Some scholars believed that the internal grain was more likely to produce stress concentration under low

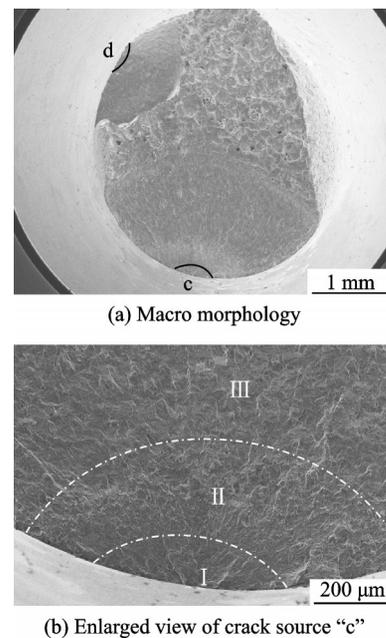
Fig.6 Fractography arising from surface with stress amplitude of 558 MPa and life of  $1.6 \times 10^6$  cycles

Fig.6 shows the fatigue fracture morphology with a stress amplitude of 558 MPa and a life of  $1.6 \times 10^6$  cycles. From the macro fracture in Fig. 6 (a), it can be seen that the crack originated on the surface and had two crack sources (c and d). Due to the high stress amplitude (558 MPa), with the increase of cycles, the phenomenon of extrusion furrows and extrusion ridges were formed between the residing slip bands, and they would be coupled with the oxides on the surface of the inclusions, resulting in the initiation of fatigue cracks on the surface, and it was easy to generate multiple crack sources. When the stress amplitude was low, only the optimally oriented slip system slips along a specific plane, and finally a single crack source was formed<sup>[23-25]</sup>.

Fig.6(b) is an enlarged view of the crack source of "c" in Fig. 6 (a). It can be seen that the fracture surface of the fatigue specimen is flat and there are clear stream-like stripes extending to the center of the specimen at the crack initiation point. According to the morphology, the fracture is divided into three regions: I is the crack source region. II is the crack initiation area, which has large fluctuation and relatively rough section. III is a stable extension area with a flat section.

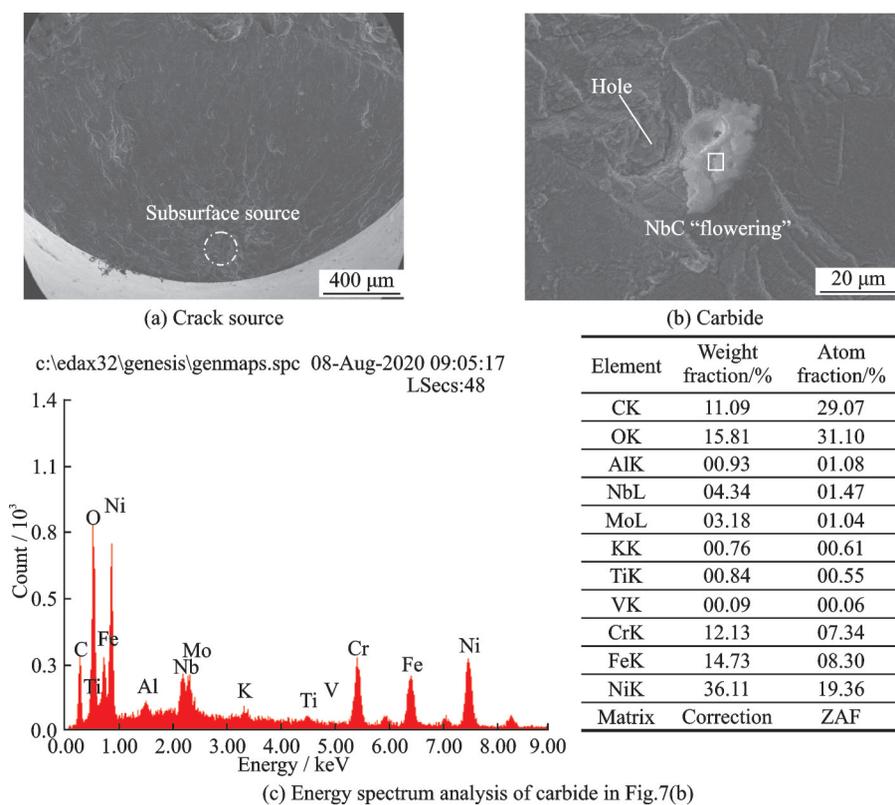
Fig.7 Fractography arising from inside with stress amplitude of 508 MPa and life of  $1.2 \times 10^7$  cycles

Fig.7 shows the fatigue fracture morphology with a stress amplitude of 508 MPa and a life of  $1.2 \times 10^7$  cycles. The specimen life has entered the ultra-high cycle stage and the crack source has transferred from the surface to the subsurface. There is a competitive relationship between crack source initiation and surface initiation. For internal initiation, there is also a competition between the inclusion and the matrix. Therefore, the competition for the initiation location of ultrahigh cycle fatigue cracks in the metal is a key problem that needs to be further studied<sup>[26]</sup>. When the stress amplitude is reduced to a cer-

It can be seen from Fig.7(b) that the NbC phase in the extension area has been greatly expanded in volume and seriously cracked itself, leading to the appearance of "flowering" phenomenon. Energy spectrum analysis of the red marked area shows that the oxygen content is very high. The carbides can even fall off, leaving holes where they used to be. Hou and Lyu et al.<sup>[28-29]</sup> also found the same phenomenon in the study on high temperature fatigue of GH4169 alloy. When these carbides are subjected to cyclic loading under high temperature environment, the deformation cannot be coordinated because the elastic modulus and thermal expansion coefficient are different from that of the matrix, and the dislocation movement will result in blocking and plugging. This will result in stress concentration between carbide and matrix and lead to secondary cracks. Therefore, in order to improve the fatigue strength of the alloy, the size and number of particles of the second phase should be controlled in the matrix<sup>[30-31]</sup>.

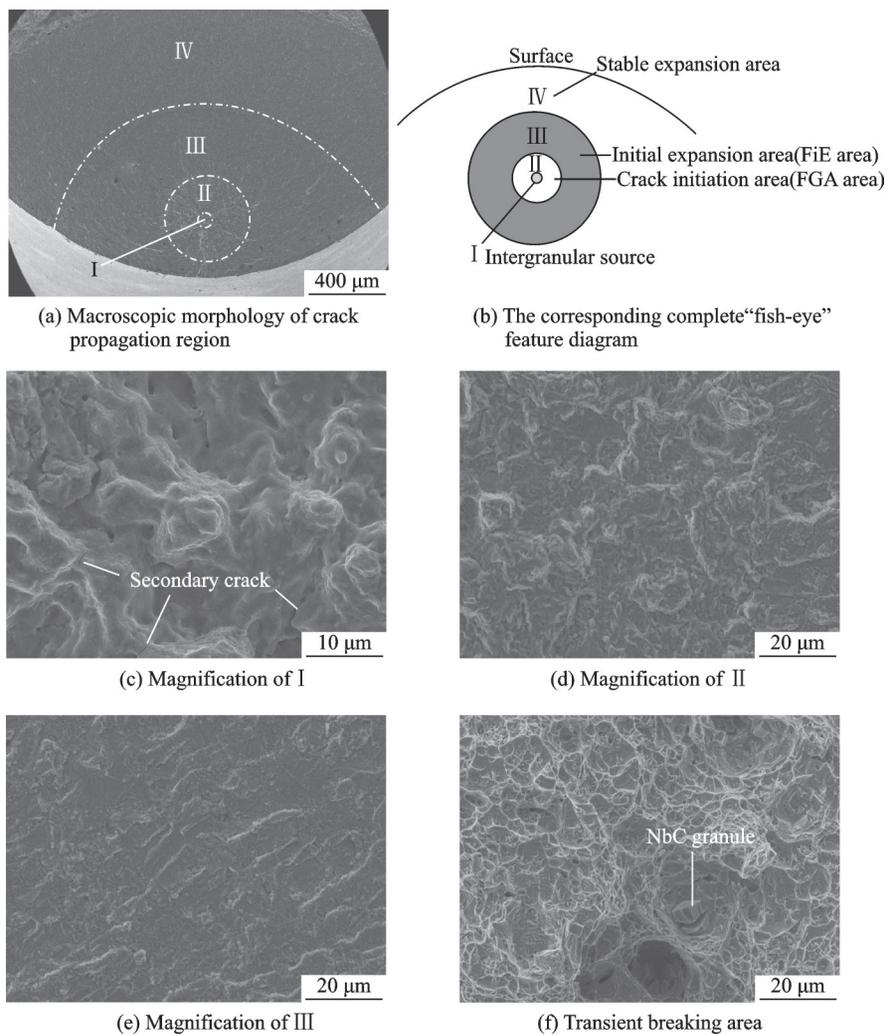
Fig.8 Fractography arising from inside with stress amplitude of 452 MPa and life of  $4.2 \times 10^8$  cycles

Fig.8 shows the fatigue fracture morphology with a stress amplitude of 452 MPa and a life of  $4.2 \times 10^8$  cycles. It can be seen that the crack initiation is in the interior and the whole growth area is relatively flat. A similar “fish-eye” characteristic morphology is found. Because the source is close to the surface, “fish-eye” features are incomplete. Fig.8(b) is the corresponding complete “fish-eye” feature diagram. I (Fig.8(c)) is the source of the crack. It is the intergranular fracture of the matrix and located in the center of the “fish-eye”. II (Fig.8(d)) is the crack initiation area (FGA area). This area has a rough cross-section with large fluctuation and is bright under scanning electron microscope. Therefore, it is also known as the granular bright area (GBF area). III (Fig.8(e)) is the initial extended area (FiE area) with “fish-eye” characteristics. The section of this area is relatively flat. According to measurement by Liu et al.<sup>[32]</sup>, the roughness of FGA region in “fish-eye” feature area was one order of magnitude greater than that of FiE region. The region in Fig.8(a) is the steady-state crack propagation region outside the “fish-eye”. In the ultrahigh cy-

Fig.8(c) shows the morphology of the fracture source region, and it can be seen that the fracture is basically intergranular, that is, the main crack is generated intergranularly from the beginning. The surface of the fracture is covered with a layer of granular material and uneven, which is actually the oxidation product formed after severe oxidation. Meanwhile, secondary cracks along the grain boundary have also been observed. Fig.8(d) shows the morphology of the crack initiation zone at  $100 \mu\text{m}$  away from the crack source, and it can be seen that the crack initiation zone is a mixed propagation form of intergranular and quasi-cleavage. Fig.8(e) shows the initial growth zone morphology at a distance of  $300 \mu\text{m}$  from the crack source. It can be seen that the section is relatively flat with a large number of

stream-like stripes along the crack growth direction, which is a typical cleavage fracture feature. Observation of the instantaneous fault zone of the crack (Fig.8(f)) showed that there were a large number of small dimples and some large holes with the size of 10—20 μm formed by NbC phase, indicating that the instantaneous fault zone was ductile.

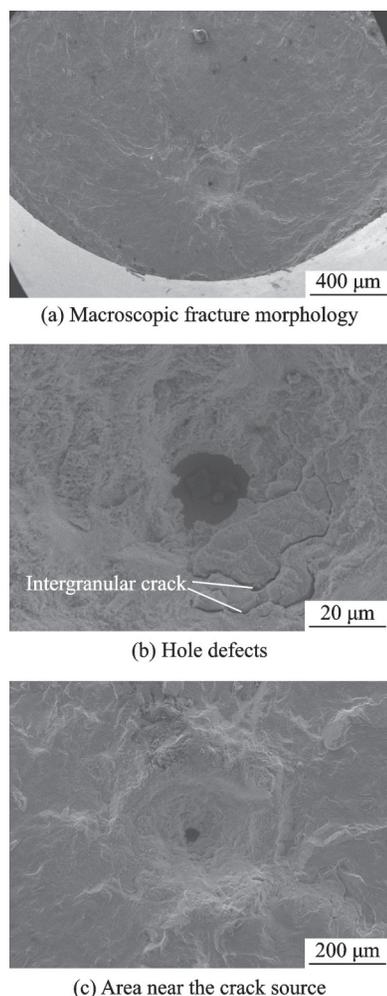
Fig.9 Fractography arising from inside with stress amplitude of 452 MPa and life of  $1.85 \times 10^8$  cycles

Fig.9 shows the fatigue fracture morphology with a stress amplitude of 452 MPa and a life of  $1.85 \times 10^8$  cycles. The macro morphology in Fig.9 (a) shows that the crack originated from the inside and originated from the casting hole defect with a diameter of about 20 μm (Fig.9(b)). In the process of fatigue cyclic loading, the holes produced stress concentration and formed pits with

a diameter of about 200 μm along the crystal growth as the crack initiation area (Fig.9(c)), and there were many secondary cracks along the crystal in the pits. Due to the large area of the crack initiation area, the characteristics of the initial expansion area are not obvious, so there is no “fish-eye” formation feature on the macro fracture morphology.
