Research on High-Velocity Impact Damage Monitoring Method of CFRP Based on Guided Wave

WANG Yang, YANG Xiaofei, QIU Lei*, YUAN Shenfang

State Key Laboratory of Mechanics and Control for Aerospace Structures, Research Center of Structural Health Monitoring and Prognosis, Nanjing University of Aeronautics and Astronautics, Nanjing 210016, P. R. China

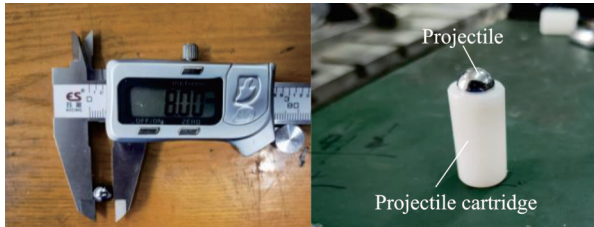
In this paper, a one-stage light gas gun using gas compression propulsion is selected for test. The device can launch projectiles below 12.7 mm and the maximum launching speed is 600 m/s. A ball-bearing steel with a diameter of 8 mm is selected as the launching projectile, whose projectile body and supporting projectile support are shown in Fig.4, with a mass of 2.01 g. The expected impact speed is 450 m/s and the expected impact angle is vertical plate surface, just meaning the normal of the plate surface is 0°. The launch impact is on the surface without an attached sensor, while the surface attached with PZT sensor is the impact back. The key design parameters of the test are shown in Table 2.

Fig.4 Projectile and its cartridge

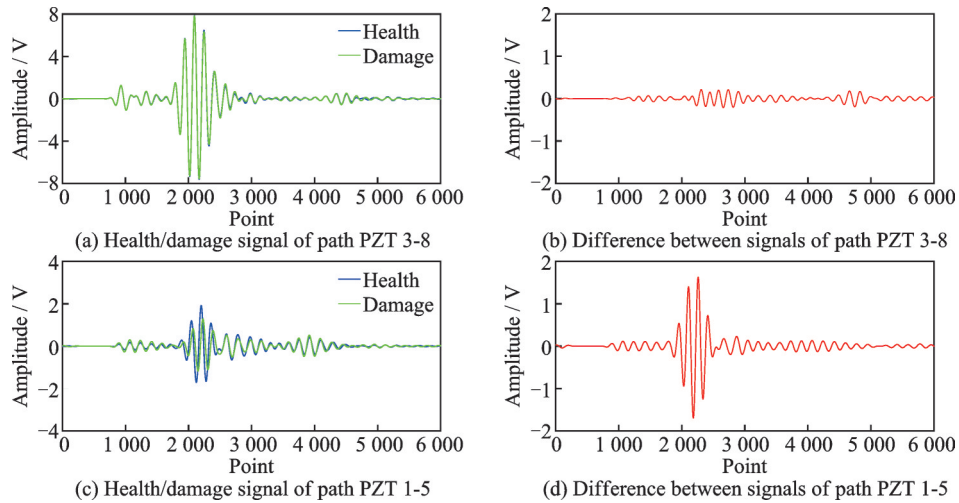
Fig.13 No.2 typical health/damage signals and their difference
