Experimental Study on Peck Drilling of Micro-holes in Fully Sintered Zirconia Ceramics Using Diamond-Coated Drill Bits

Abstract: Zirconia (ZrO_2) ceramic material has been widely applied to various fields due to its unique properties of high strength, high hardness, and excessive temperature resistance. However, the high-quality micro-hole machining of zirconia ceramic material remains a significant challenge at present. In this study, experiments on peck drilling of $\emptyset 0.2 \text{ mm}$ and $\emptyset 0.5 \text{ mm}$ micro-holes in zirconia ceramics using diamond-coated drills are conducted. The characteristics of the force signal during the drilling process, the influence of drilling parameters on the drilling force and the chipping size at the hole exit, and features of the tool wear stages of the diamond coated drill are analyzed. Experimental results suggest that when machining micro-holes in zirconia ceramics, there is a positive correlation between the axial force and the size of the chipping at the exit. The axial force increases with the increase of the spindle speed. The wear of the drill bit has a significant impact on the quality of the hole exit. It is found tha

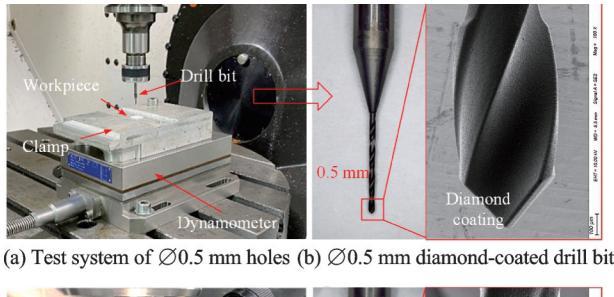
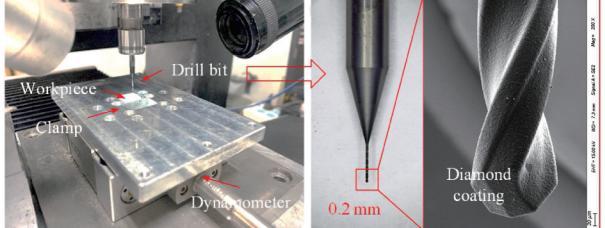
(c) Test system of \emptyset 0.2 mm holes (d) \emptyset 0.2 mm diamond-coated drill bit Fig.1 Experimental setups

As shown in Fig.1, the \emptyset 0.5 mm hole drilling tests are conducted on a five-axis precision machining center (Mikron MILL E 500U, Swiss). The machine tool adopts C type cast iron body structure

with high rigidity and stability, which can ensure the machining accuracy and process stability. The maximum rotating speed of the spindle is 12 000 r/min. While the \emptyset 0.2 mm hole drilling tests are carried out on a self-developed three-axis micro milling center. The machining center features a linear motor-driven platform with high-precision positioning capabilities. The maximum spindle rotating speed is about 100 000 r/min, which can ensure a certain cutting speed when the tool diameter is very small.

To monitor the cutting force during drilling process, the Kistler dynamometer system is used. The dynamometer is installed on the base of the machine tool, and then the workpiece is fixed on the aluminum base plate through high-strength adhesive. In addition, SEM is used to observe the tool wear of the drill bit and the quality of the hole outlet.

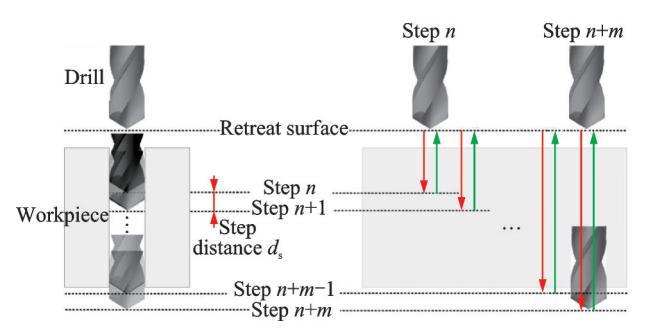
Fig.2 Schematic diagram of peck drilling processing

Since the diameter of the processed hole is relatively small and the depth-diameter ratio is about 2—5, continuous drilling is not conducive to the removal of chips. Therefore, the intermittent pecking drilling process is adopted in the machining process experiment, as shown in Fig.2. The conventional continuous-feed drilling process for through-holes is modified to adopt a peck drilling strategy. In this approach, the drill bit advances to a predetermined depth increment (fixed step distance d_s), then fully retracts to the workpiece surface after each penetration. This peck-and-retract cycle repeats iteratively until the full hole depth is achieved.

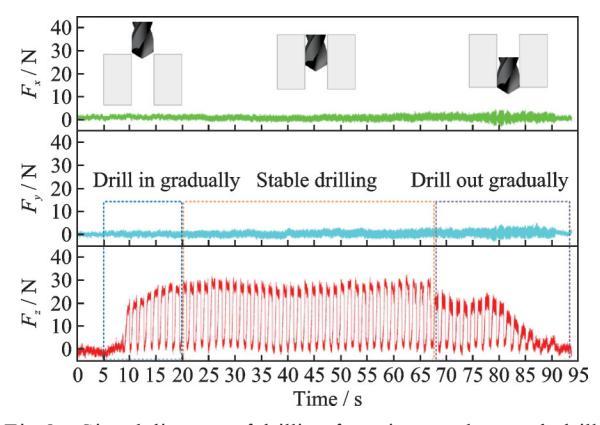
Fig.3 Signal diagram of drilling force in complete peck drilling process

Fig.3 shows a typical time-domain diagram of three-directional drilling force signals throughout the entire process when a $\emptyset 0.5$ mm diamond coated drill bit is used to drill zirconia ceramics under n=7 500 r/min, f = 1.5 mm/min, and $d_s = 0.02$ mm. As can be seen from Fig.3, the fluctuations of F_x and F_{ν} signals are very small, and the amplitudes are basically within 3 N. However, the axial force F_z is relatively large, obviously presenting the characteristics of intermittent drilling during the pecking drilling process. Judging from changes in amplitude and interval, at the initial stage of drilling, as the drill bit gradually penetrates, the axial force gradually increases. Subsequently, it enters a stable drilling process and fluctuates within a certain range. In the later stage of drilling, the feed rate decreases, and as the drill bit gradually exits, the volume of the material removed by the main cutting edge of the drill bit continuously decreases. Therefore, the axial force gradually decreases.

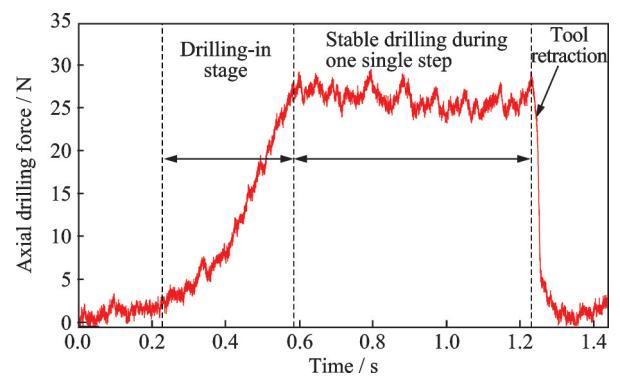
Fig.4 Typical axial force signal of a single feed cycle

Fig.4 shows a typical diagram of the axial force signal for a single step. As can be seen from Fig.4, the drilling force signal initially rises slowly for a certain period. Subsequently, it stabilizes and fluctuates within a certain range. Finally, as the tool is retracted rapidly, the axial force returns to zero.

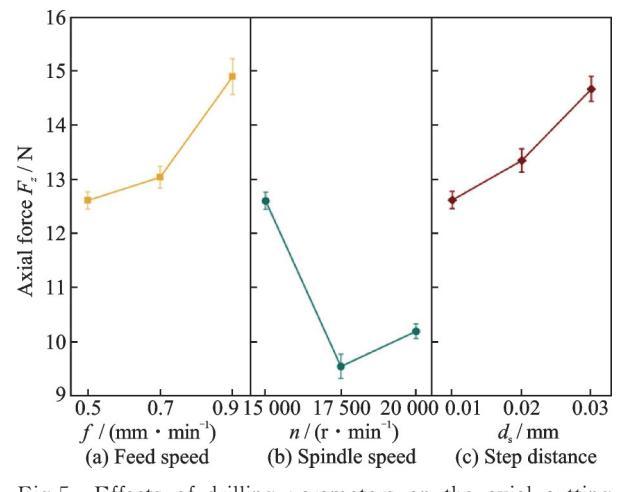
Fig.5 Effects of drilling parameters on the axial cutting force with $\emptyset 0.2$ mm drill bit

Fig.5 and Fig.6 show the influence of the drilling parameters on the axial force F_{z} when drilling zirconia ceramics with $\emptyset 0.2$ mm and $\emptyset 0.5$ mm drill bits, respectively.

It can be seen from Fig.5(a) that as the feed speed increases, the axial force gradually increases. When the feed speed f increases from 0.5 mm/min to 0.7 mm/min, the axial force F_z increases by 0.43 N, while the feed rate increases from 0.7 mm/min to 0.9 mm/min, the axial force increases by 1.86 N, showing an increase of more than four times. Fig.6(a) also shows a similar change of cutting force. Generally speaking, the increase in feed speed will increase the cutting thickness per revolution in drilling, and the load on the cutting edge of the bit will also increase.

Although increasing the feed speed can reduce the time required and improve the processing efficiency, it is necessary to take into account the wear of the drill bit and the stability of the processing process. At the same time, because the drill bit diameter is small and large axial force may cause the risk of breaking of drill bit, so it is recommended to use smaller parameters for feed speed.

Fig. 5(b) and Fig. 6(b) show changes of axial force F_z at different spindle speeds. It is shown that as the spindle speed increases, the axial force first decreases and then increases. When the spindle speed is relatively high, the relative movement speed between the tool and the workpiece material increases, leading to an increase in tool wear. When the spindle speed is relatively low, the cutting speed of the tool decreases, resulting in an increase in the axial force. Therefore, it is recommended to select a moderate spindle speed.

Another influencing factor is the feed step distance. Fig. 5(c) and Fig. 6(c) show the influence of different step distances on the axial drilling force when two types of drill bits are used. As can be seen from the figures, in both cases, the changes in the axial drilling force are similar, and it increases with the increasing of the step distance.

There may be several reasons for this phenomenon. On one hand, when the step distance d_s increases, continuous drilling will increase the friction and extrusion between the cutting tool and the zirconia material, thus increasing the axial force. On the other hand, when the single-step distance increases, the drilling time becomes longer, resulting in more chips accumulating in the hole, which will cause an increase in the axial force.

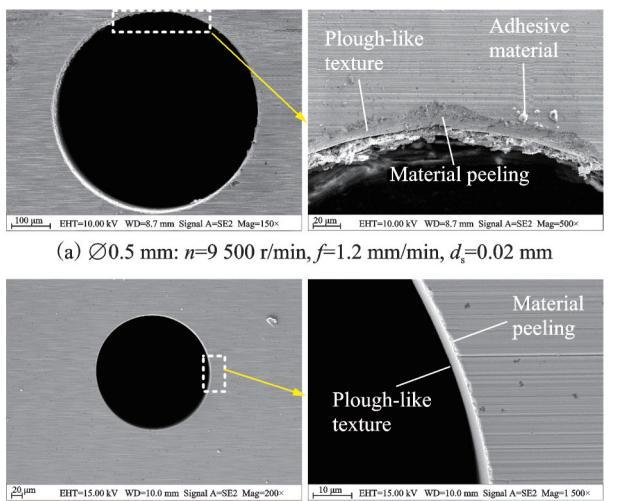
(b) \emptyset 0.2 mm: *n*=15 000 r/min, *f*=0.5 mm/min, *d*_s=0.01 mm Fig.7 SEM images of micromorphology at hole entrance

Fig.7 shows typical morphologies of micro hole entrances with different diameters. As shown in Fig.7(a), the overall morphology of the entrance of the hole with a diameter of 0.5 mm is presented. The shape of the hole is very regular, and there are no obvious defects on the overall entrance surface of the hole. From the locally enlarged image, it can be seen that there is a slight fragmentation at the edge of the entrance. The material is removed in the form of brittle failure, and a shape similar to a chamfer is formed. In addition, some chip residues are adhered to the hole opening.

However, in Fig.7(b), the entrance of the hole with a diameter of 0.2 mm shows better quality. As can be observed from the locally magnified image, the edge of the hole is very smooth, and there is no brittle failure area similar to that at the edge of the 0.5 mm hole. It may because that the feed rate of drilling process in this hole is only 0.5 mm/min, and the lower feed rate enables the material to be removed in the ductile regime, resulting in better machining quality.

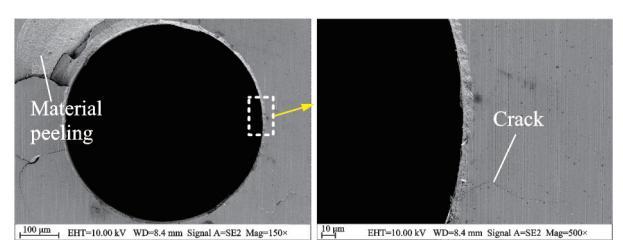
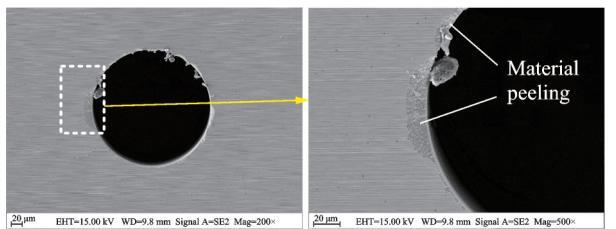
(b) \emptyset 0.2 mm: *n*=20 000 r/min, *f*= 0.5 mm/min, *d*_s=0.01 mm Fig.8 SEM images of micro morphology at hole exit

Different from the entrance, the quality of the micro-hole exit varies greatly. Fig.8 shows morphologies of hole exits with different diameters. As shown in Fig.8(a), the exit morphology of the 0.5 mm hole is presented, which is drilled with big feed rate and step distance. It can be seen that a large-area chipping morphology appears in a specific area, accompanied by obvious crack propagation. The material in the chipping area undergoes massive brittle fracture. This is mainly because the bottom material is squeezed by the drill bit during the feed. When the drill bit exits, the material is broken under the action of drilling force.

(a) Ø0.5 mm: *n*=9 500 r/min, *f*=1.5 mm/min, *d*_s=0.03 mm

During the drilling process, when the drill bit gradually drills out of the bottom of zirconia ceramic, the material in the exit area will undergo tensile failure under the pressure of the drill bit. At this time, with the wear of drill bit, the cutting force will also gradually increase, and the thickness of ceramic material to be removed will gradually decrease. When the thickness is small to a certain extent, the stress of the remaining material at the hole outlet will be lower and lower. When the tensile stress caused by the drill bit feeding on the material gradually exceeds the extreme value of the fracture stress of the material, cracks begin to appear inside the material, and as cracks continue to expand, serious edge collapse occurs at the hole exit.

Similarly, at the exit of the 0.2 mm hole, there is also chipping of the material within a certain range. Compared with the 0.5 mm hole, the chipping area is much smaller. This also shows that under the condition of a smaller feed rate, the range of chipping at the exit is also smaller.

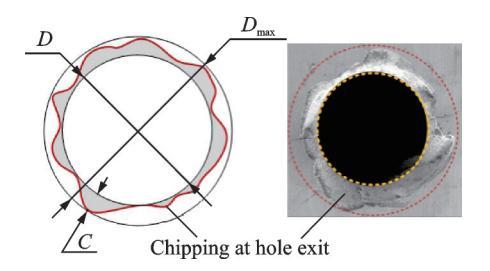
Fig.9 Measurement method of edge chipping size

In the drilling process of zirconia ceramics, the pattern of the chipped edge at the hole exit is usually presented in an irregular shape, and the size is rather random and unpredictable. Therefore, as shown in Fig.9, the maximum dimension of the chipped edge C is measured as one of the processing quality standards^[26]. The calculation formula is shown as

$$C = (D_{\max} - D)/2 \tag{1}$$

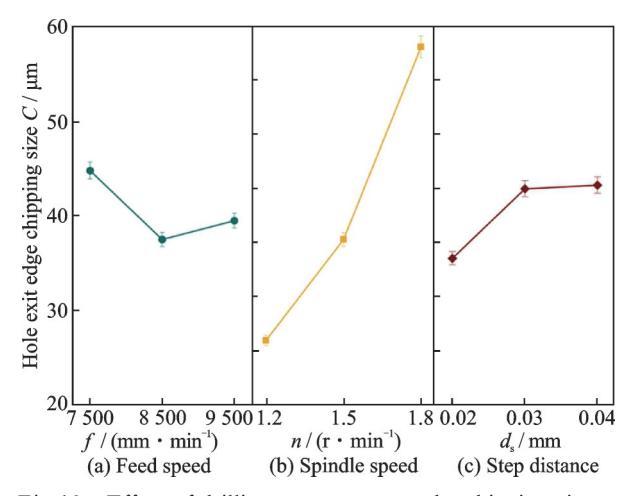
Fig.10 Effect of drilling parameters on the chipping size at exit of $\emptyset 0.5$ mm holes

Fig.10 shows the influence of drilling parameters on the chipping size at the exit of the microhole. It can be seen from Fig.10 that the feed rate has the greatest influence on the chipping size. As the feed rate increases from 1.2 mm/min to 1.8 mm/ min, the chipping size increases from 27 μ m to about 57 μ m. The reason may be that when the feed rate increases, the volume of material removed per unit time increases, and the axial force increases, which leads to an increase in the chipping size.

As the spindle speed increases, the chipping size at the hole exit first decreases and then increases. As the step distance increases, the chipping size also gradually increases. The above rules are similar to the analysis results of the influence of machining parameters on the axial force. According to the analysis of chipping generation, the chipping size should increase with the increasing of the axial force. Therefore, in order to reduce the chipping size at the exit of the micro-holes drilled in zirconia ceramics, firstly, a lower feed rate should be selected. Secondly, a smaller step distance should be chosen, and the spindle speed should be controlled within a moderate range.

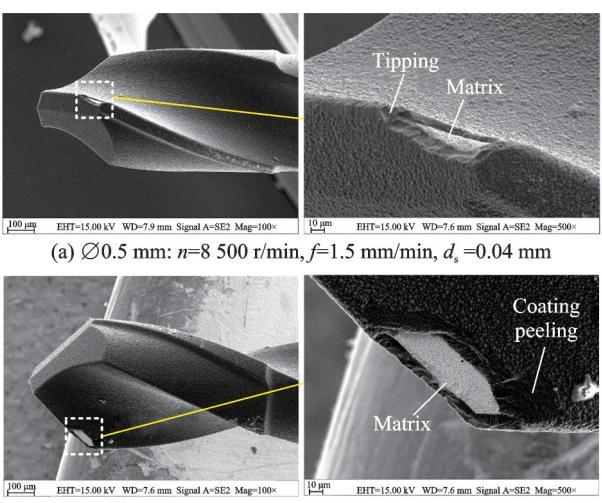
Fig.11 SEM images of microscopic morphology of coating delamination

Fig.11 shows the micro-morphology and local enlarged SEM images of the \emptyset 0.5 mm drill bit processed with different processing parameters. It can be seen from Fig.11 that under different processing parameters, the drill bit wear morphology characteristics are relatively similar, and the wear is mainly concentrated on the main cutting edge and the front and rear cutting edges.

(b) \emptyset 0.5 mm: *n*=7 500 r/min, *f*=1.8 mm/min, *d*_s =0.03 mm

ramic materials, the material removal mechanism differs from that of metal. Under the extrusion of the cutting edge, chips are generally removed in the form of brittle fracture and do not contact with the rake face of the drill, so the rake face is slightly worn^[27]. However, the cutting thickness of this machining is far less than critical cutting thickness, and the material is removed in a ductile mode. Therefore, during the drilling process, a small part of tiny chips generated by the ZrO₂ ceramic will stay in the contact area between the tool and the workpiece. With the progress of drilling, serious friction occurs in the contact area, making the cutting edge with lower strength wear first.

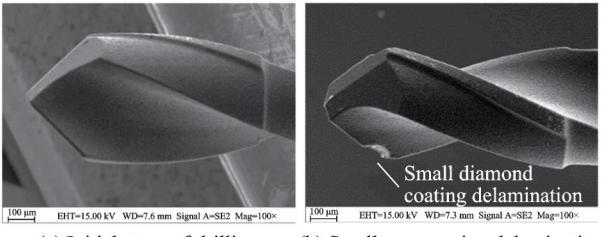
Fig.12 SEM images of typical wear morphology of the drill bit at different stages under n=9500 r/min, f=1.2 mm/min and $d_s=0.02$ mm

Fig.12 shows the change process of tool wear of the \emptyset 0.5 mm diamond-coated drill bit after continuous drilling under specific parameters. As can be seen from Fig.12, the diamond-coated drill bit has gone through several stages, including the micro delamination of the diamond coating, large-scale delamination of coating, and wear of substrate material. This is similar to the wear and failure process of most diamond-coated cutting tools^[19, 28]. Fig.12(a) shows the appearance of the tool in the initial stage of drilling. The coating is intact, and there is no exposure of the substrate material. Fig.12(b) shows that after drilling several holes, the coating shedding occurs at the cutting edge, exposing the sub-

(a) Initial stage of drilling

(b) Small-area coating delamination

(c) Large-scale coating delamination and substrate wear

strate material. Fig.12(c) shows that in the later stage of drilling, a large area of the coating on the drill bit sheds, exposing a large amount of cemented carbide substrate material. Moreover, after the substrate material at the drill tip loses the protection of the coating, it suffers from severe wear.

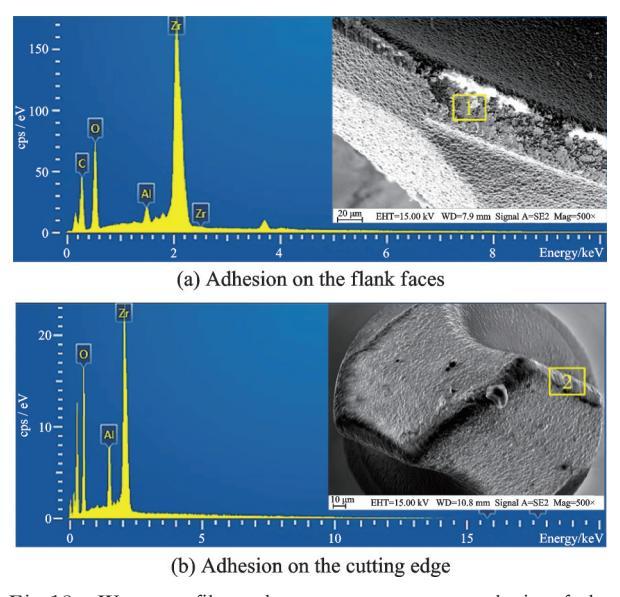
Fig.13 Wear profile and energy spectrum analysis of the drill bit

During the drilling process of zirconia ceramic, there is chip adhesion on the diamond-coated bit. SEM images of bit wear after processing and EDS energy spectrum analysis are shown in Fig.13. It can be seen from Fig.13 that there is white adhesive in the wear area of the rake and flank faces of the tool. According to the analysis results, the white binders at these two points are mainly contains Zr and Al elements, while the diamond coating mainly contains C element. It can be inferred that the adhesive on the surface originates from the zirconia ceramic and the aluminum plate substrate.

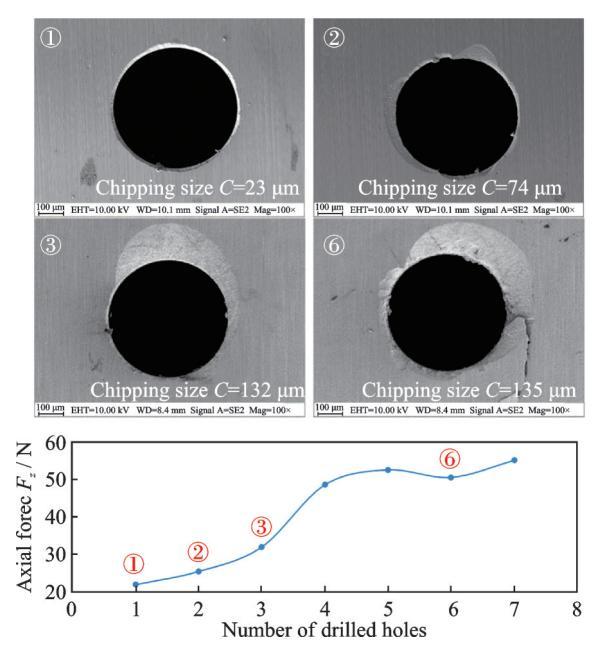
Fig.14 Influence of tool wear on drilling force and exit edge chipping

The wear of the drill bit has an important impact on the axial drilling force and the machining quality on the hole exit. As shown in Fig.14, it is the variation of the drilling force with the number of drilled holes during the process of continuously drilling multiple holes with the same drill bit. As can be seen from the figure, with the increase in the number of drill holes, the axial force generally shows an upward trend, and the variation range of the axial force is very obvious. The axial force gradually increases from 22.4 N to 54.7 N, with an increase rate as high as 144.2%. This is mainly because as the number of drill holes increases, the drill bit continuously wears during processing. The cutting edge at the drill tip becomes blunt, and the contact area between the flank face of the drill bit and the zirconia ceramic increases. The friction between the two gradually increases, leading to a multiple increase in the drilling axial force.

Due to the increase in axial force, the edge chipping phenomenon at the exit of the machined hole has become increasingly severe. SEM images in Fig.14 show the morphology of edge chipping at the hole exit. From the 1st hole to the 6th hole, the size of exit edge chipping tends to increase, growing from the initial 23 µm to about 135 µm.

(4) The wear of the drill bit has an important impact on the axial drilling force and the chipping size at the hole exit. In this study, it is found that the axial force gradually increases from 22.4 N to 54.7 N, with an increase rate as high as 144.2%. The size of exit edge chipping also tends to increase, growing from the initial 23 μ m to about 135 μ m.
