# Tool Wear Mechanism and Experimental Study on Deep Hole Gun Drilling of 304 Stainless Steel

**Abstract:** Deep hole gun drilling is in a closed and semi-closed state, and the machining process is complex. The unstable drilling force, severe tool wear, and poor processing quality have always been difficulties in deep hole gun drilling. 304 stainless steel has good corrosion and heat resistance, and is widely used in various industries. However, high hardness, poor plasticity, and characteristics of sticking knives have always restricted its development in engineering applications. Therefore, this paper uses 304 stainless steel as the research object and performs process parameter optimization and tool wear experiments. Firstly, based on the optimization experiment of process parameters, the influence of cutting speed and feed rate on drilling force and hole wall roughness is analyzed. The process parameters of the subsequent experiment are optimized as follows: spindle speed is 1 270 r / mm, feed rate is 0.02 mm/r, and oil pressure is 3 MPa. Secondly, based on the tool wear experiment, the variation law of tool wear and tool wear form is studied. With the help of scanning electro

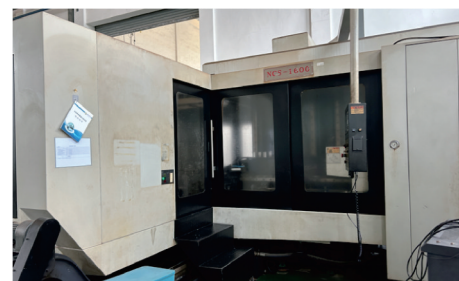
Fig.5 NCS1600 CNC machine tool

The machine tool used in the experiment is the NCS1600 CNC machine tool. The mechanical data acquisition uses KISTLER 9129AA piezoelectric dynamometer, KISTLER5073A charge amplifier, and HR-426 data acquisition system. The processing equipment is shown in Fig.5, and the equipment installation diagram is shown in Fig.6.

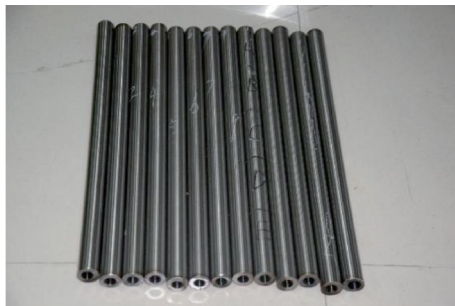
Fig.12 Processed workpieces

According to the above variable cutting speed experiment and variable feed rate experiment, the processing parameters of the wear experiment are determined, as shown in Table 5. A total of 15 304 stainless steel bars are processed in the experiment. The cumulative processing length reaches 7 500 mm, and some of the processed workpieces are shown in Fig.12.

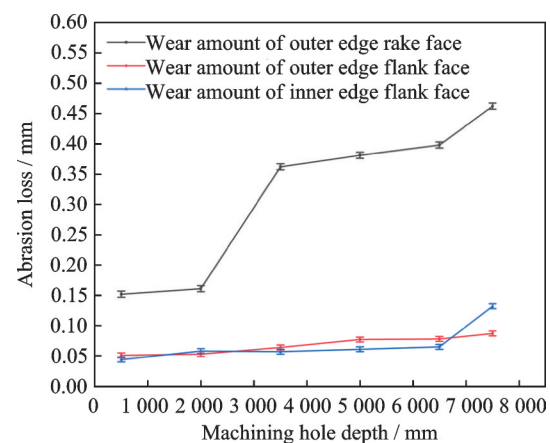
Fig.18 Variation curves of tool wear with machining hole depth

Fig.18 shows the variation curves of tool wear with machining hole depth. It is found that the wear amount of the rake face of the inner and outer cutting edges increases with the increase of machining hole depth. The wear amount of the rake face of the outer cutting edge is always more significant than that of the flank face of the outer cutting edge and the inner cutting edge. The wear on the flank face has maintained a steady growth trend. When the machining hole depth reaches 6 000 mm, the flank face of the inner cutting edge begins to aggravate wear. The wear of the rake face is pronounced. When the machining hole depth reaches 3 500 mm, the rake face is severely worn, and the wear amount reaches 0.35 mm. Fig.19 shows the variation curves of the tool burning area with the change of machining hole depth. It is found that the burning area of the rake face of the inner cutting edge is always more significant than that of the flank face of the outer cutting edge. With the increase of machining hole depth, the burning area of the flank surface of the outer cutting edge has continuously and steadily increased. The burning area of the rake face of the inner cutting edge increases sharply to 0.6 mm<sup>2</sup> when the machining hole depth reaches 3 500 mm. When the final machining hole depth reaches 7 500 mm, the burning area of the rake face of the inner cutting edge reaches 0.75 mm<sup>2</sup>.

gun drill is mainly reflected on the rake face and the flank face. The maximum width of the wear band on the rake face of the outer edge can reach 0.46 mm, and the width of the wear band on the flank face of the outer edge and the flank face of the inner edge is within 0.1 mm. The maximum ablation area on the rake face of the inner edge can reach 0.74 mm<sup>2</sup>, and the ablation area on the flank face of the outer edge is maintained at about 0.33 mm<sup>2</sup>. Through the above analysis, it is found that tool wear is mainly divided into two stages: normal wear (Machining hole depth ≤ 3 500 mm) and severe wear (Machining hole depth > 3 500 mm). In the early drilling stage, because the outer cutting edge undertakes the main cutting task, a small amount of wear occurs on the outer cutting edge's rake face and flank face. Due to the influence of drilling heat, a small amount of sur-

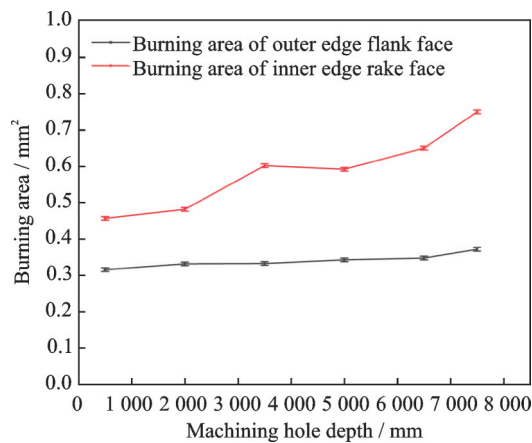
Fig.19 Variation curves of tool burning area with machining hole depth

face ablation occurs on the inner cutting edge's rake face and flank face. With the increase of drilling depth, when the cumulative machining hole depth reaches 3 500 mm, the tool wears violently, a large number of fatigue spalling occurs on the rake face of the outer cutting edge, and a large area of ablation occurs on the rake face of the inner cutting edge.

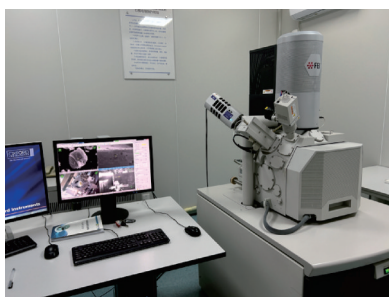
Fig.20 Nova Nano SEM 450 field emission scanning electron microscope

In order to study the wear mechanism of the tool's rake face and flank face, the Nova Nano SEM 450 field emission scanning electron microscope (SEM) is used to scan and analyze the wear of the rake face and flank face. The use of the equipment is shown in Fig.20.

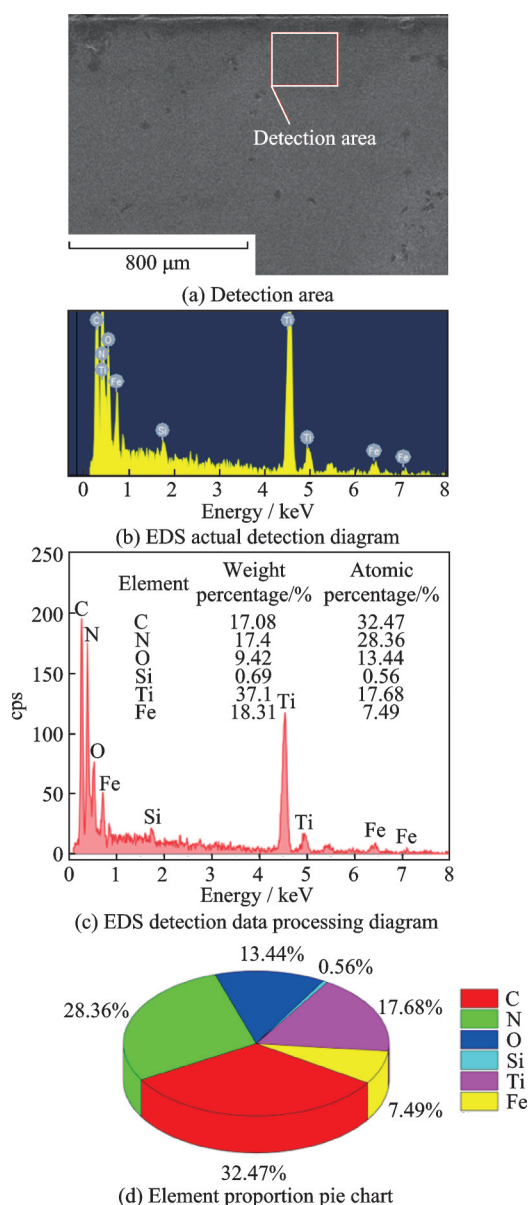
Fig.23 EDS analysis results of rake face of outer cutting edge

crease in the proportion of Fe and Si atoms is due to the diffusion of elements from the workpiece 304

stainless steel into the tool matrix. Therefore, the rake face of the outer cutting edge of the tool mainly causes adhesive wear, oxidation wear, and diffusion wear during the machining process.

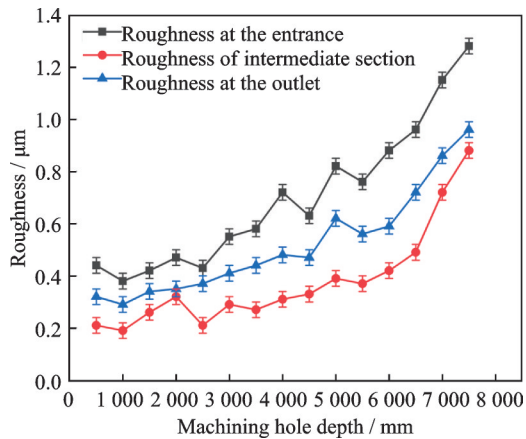
Fig.32 Curves of roughness changing with machining hole depth

Fig.32 is the curves of roughness changing with the machining hole depth. It is found that the roughness value of the workpiece increases with the increase of the processing depth. The roughness at the entrance is always more significant than that of the intermediate section and the outlet, and the roughness of the intermediate section is the smallest. Due to the tooltip at the entrance being in direct contact with the workpiece, the contact area between the tool cutting edge and the workpiece is small, and the tool has some vibration, resulting in higher surface roughness. As the drill bit ultimately enters the workpiece, the tool's cutting edge is

completely in contact with the workpiece, the processing reaches a stable state, and the surface roughness reduces compared with the entrance. When the workpiece is drilled through, the contact area between the tool's cutting edge and the workpiece gradually decreases, the tool vibrates again, and the roughness improves slightly. When the cumulative machining hole depth is less than 3 500 mm, the tool wear is better, and the surface roughness of the workpiece maintains a stable numerical fluctuation. With the increase of the machining hole depth, the tool wear is gradually severe, and the roughness increases. When the cumulative machining hole depth reaches 5 500 mm, the tool wears violently, and the roughness of the hole wall increases sharply.
